Manhole Inspection Summary

Manhole # S39I__024MH

Insp Date: **7/9/08 2:08 PM**

Location Address: **left side 815 president st**

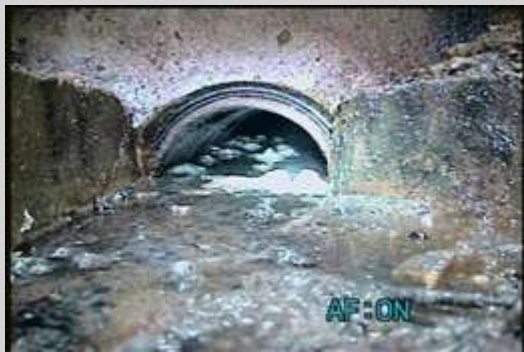
12 O'Clock Outflow

8 in. Circular Gravity Sewer
Pipe Out @ 12 O'Clock

Pipe Height: 0 (in.) Direct

Pipe Material: Clay ☐ Pipe Lined

Invert Depth: 13.90 (ft.) Flow Characteristics: Slow

Deposits: ☒ None ☐ Mud ☐ Sludge ☐ Debris ☐ Grease

Infiltration: None Pipe Seal Cond: Unknown

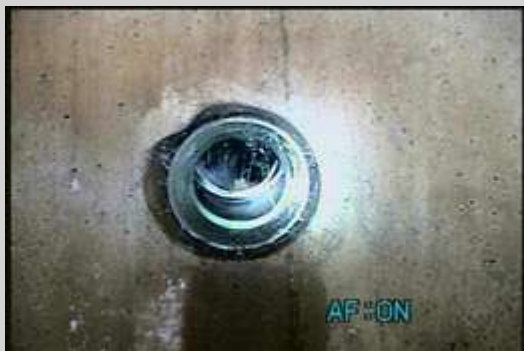
3 O'Clock Inflow

8 in. Circular Gravity Sewer
Pipe In @ 3 O'Clock

Drop In @ 3 O'Clock

Invert Depth: 9.50 (ft.) Flow Characteristics: Slow

Deposits: ☒ None ☐ Mud ☐ Sludge ☐ Debris ☐ Grease

Drop: Outside Direct

Drop Condition: Open

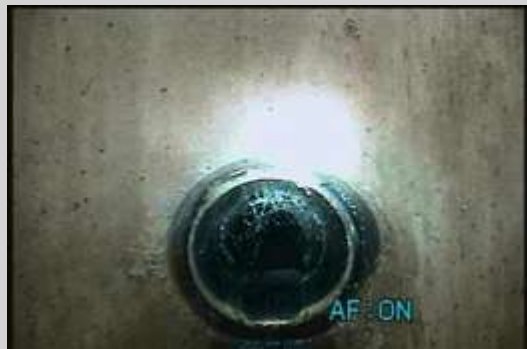
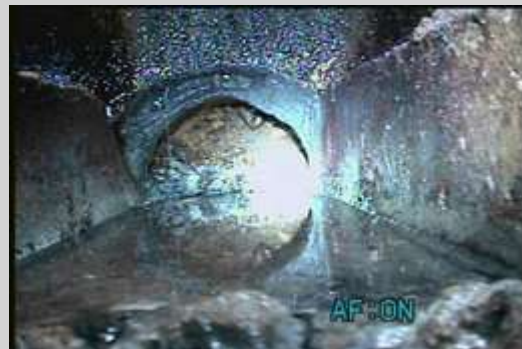
6 O'Clock Inflow

8 in. Circular Gravity Sewer

Pipe In @ 6 OClock

Drop In @ 6 OClock

Pipe Material: **Clay** ☐ Pipe Lined

Infiltration: **None** Pipe Seal Cond: **Unknown**

Drop Condition: **Open**
